# **HINKLEY POINT A SITE**

**Gabion Wall Briefing for the SSG - July 2023**

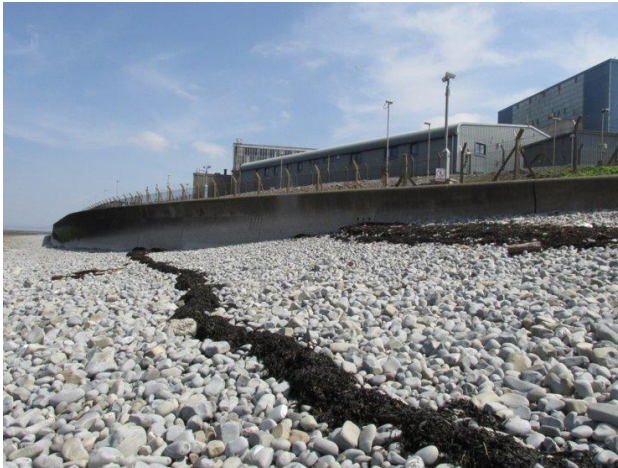
Hinkley is protected by a concrete sea wall which runs north of the site. A picture of this configuration is shown below:

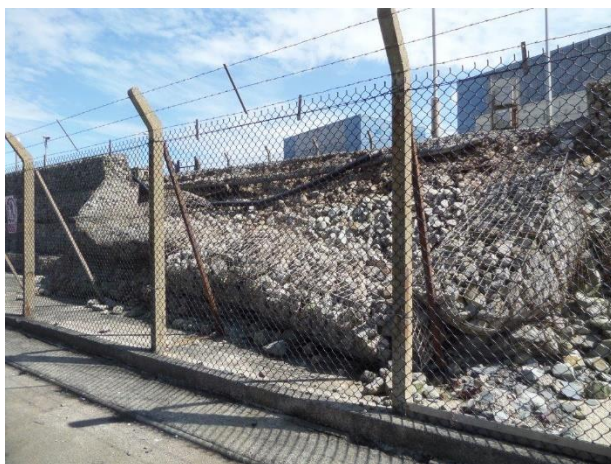
On 17/05/2021, it was identified that a western section of the Gabion Wall at Hinkley Point A had collapsed. The collapse did not result in any injuries to personnel or any significant damage to the adjacent security fence positioned to the north.

A photo showing the extent of the collapse is provided below:

Although further movement has been noted, the profile of the collapsed section remains relatively consistent with that of the resultant configuration following the initial collapse on the 17/05/2021.

Following on from the collapse, work was undertaken to remove the top layer of gabion baskets. The intent of this work was to remove loading from the lower-level gabion baskets to reduce the potential for further collapse due to cascade failure. HPB were engaged as part of this work pack development.

The section of the gabion wall which collapsed was left in its resultant configuration as whilst some further settlement of the collapsed section was judged to be likely, overall, the configuration was deemed to be stable and there were no undue concerns regarding the short-term stability. It was determined that on a risk basis it was as low as reasonably practicable (ALARP) to leave the gabion wall in its condition whilst full scale works were developed.
